A Green Infrastructure Audit of the Victoria Business Improvement District

Green Infrastructure Audit of the Victoria BID

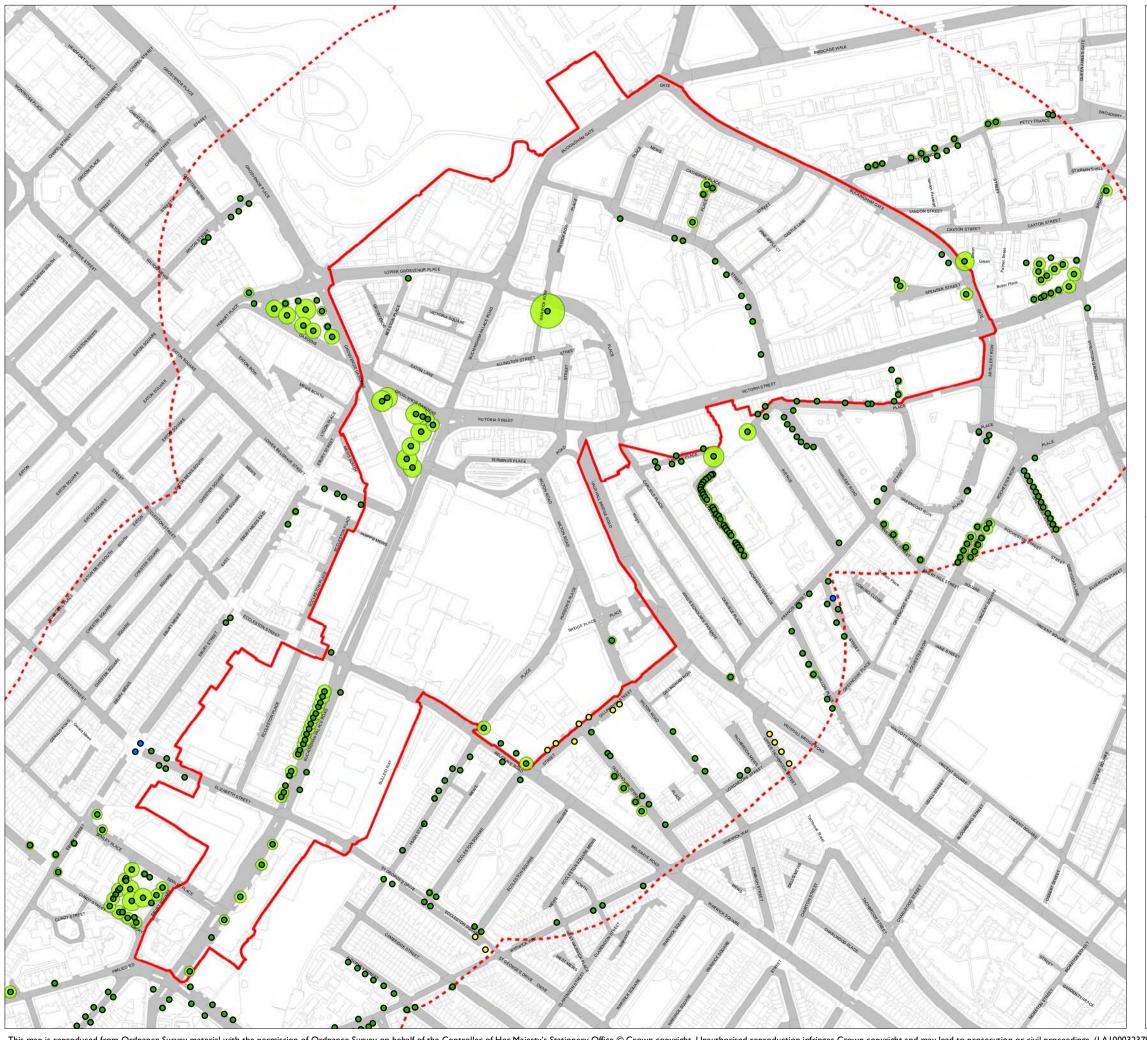
Figure 3.1: Public realm trees

- Location
- Species
- Grid reference
- Height (m)
- Canopy spread (diameter in m)
- Age
- 3.16 In addition to the data on existing trees, the dataset also contains information on 'vacant tree pits' and 'suitable for new tree location'. It is unclear from the GIS data on what basis these 'new tree locations' have been identified. For the purposes of this analysis, the trees have been broken down by location into threes that are:
 - Within the core area (Victoria BID zone)
 - Within the outer zone (within 200m of the Victoria BID area)
- 3.17 **Table 3.2** shows the breakdown of trees by location and category within the database. **Figure 3.1** shows these trees focused in on the core and outer areas.

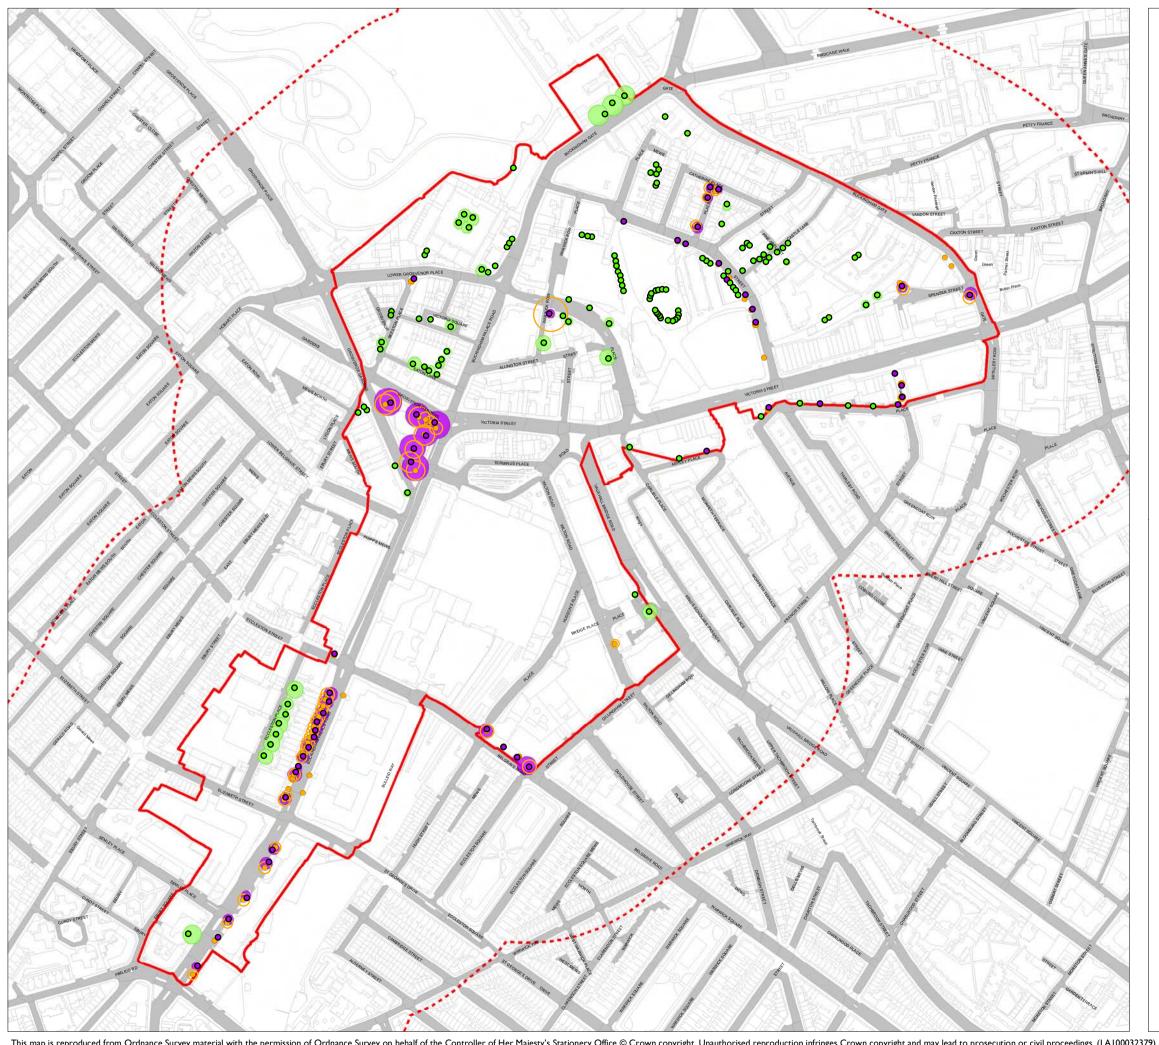
Figure 3.6: Comparison of ProximiTREE and Public Realm tree data

- 3.11 As part of the ground-truthing exercise, the accuracy of the tree locations within ProximiTREE was checked in the field. Each auditor had field maps showing both tree datasets (and the ProximiTREE canopies). On the whole, the locations were deemed to be accurate. In a couple of cases, new trees were identified or it was noted that trees had been removed. Access to Private realm trees was limited, and unfortunately aerial photography was not available for use in GIS. This is explored in more detail later in this section.
